BPG Inspection, LLC

**1930 Conner Street
Noblesville IN 46060**

Client(s): Anderson
Inspection Date: 10/30/2024
Inspector: Rob Rehm , HI00500115 (IN)

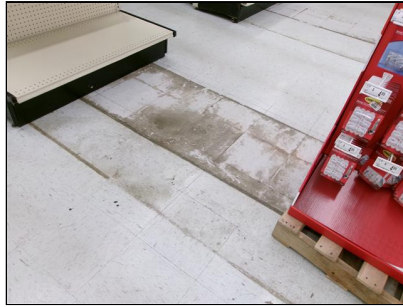
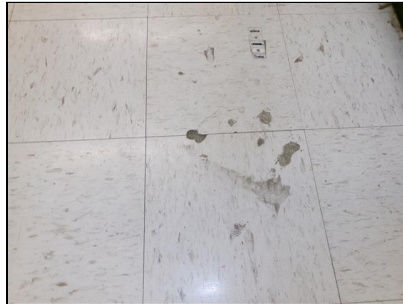
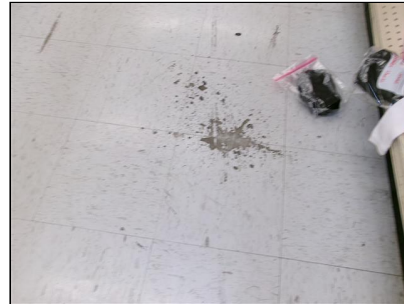
- ❌ 15. There are isolated vinyl floor tiles through out the retail area that are stained and have some surface damage. Repair or replace tiles as needed. Item 19(Picture) Item 20(Picture) Item 21(Picture) Item 22(Picture) Item 23(Picture) Estimated cost to cure will depend on work performed. Stripping and refinishing this type of flooring you can expect a cost of an estimated \$2.00 per square foot.

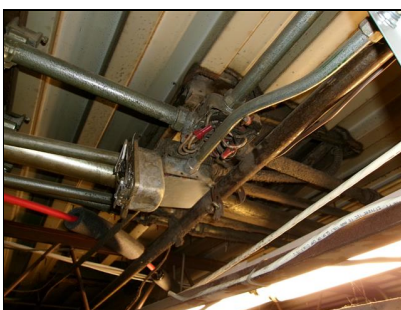
- ✗ ◆ There are at least three open electric junction boxes at the ceiling in the upper former compressor room. Cover plates should be installed at all open electric boxes for safety. Item 1(Picture) Item 2(Picture) Item 3(Picture)
Estimated cost to cure: \$300 - \$400

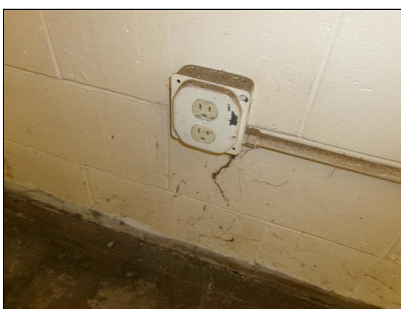
- ◆ Outlets behind equipment or otherwise inaccessible were not checked.
- ✗ ◆ There are electrical outlets in the employee break room and at the rear NW warehouse storage room that are inoperative. This could be due to some breakers are shut off at the panel boxes. Resetting breakers is outside the scope of the inspection. Have an electrician evaluate and correct as needed. Item 1(Picture) Item 2(Picture) Item 3(Picture)

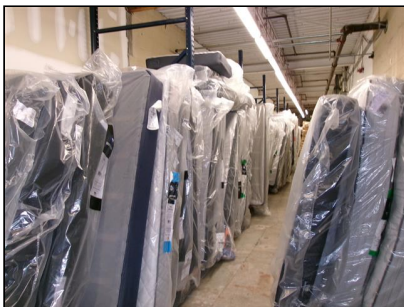
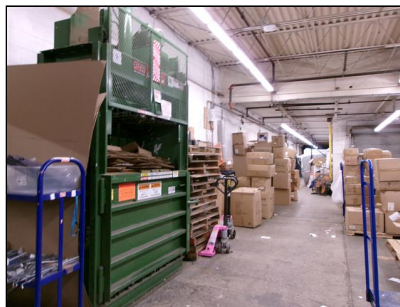
♦ Interior inspection is limited due to stored items. Item 1(Picture) Item 2(Picture)
